VI VE MT VESSEL INSPECTION REPORT

CLIENT	CNRL 2500, 855 - 2nd Street SW Calgary, Ab T2P 4J8	A Number	A0191862
CLIENT REP	Kyle Huculak RALSTON 5-14 (1339)	Ser Number	81-7900-A
		Equipment	FREE WATER KNOCK OUT
		Inspec Date m/d/y	09/08/2015
		Facility	RALSTON 5-14 BATTERY
		LSD	05-14-018-10W4 BATTERY

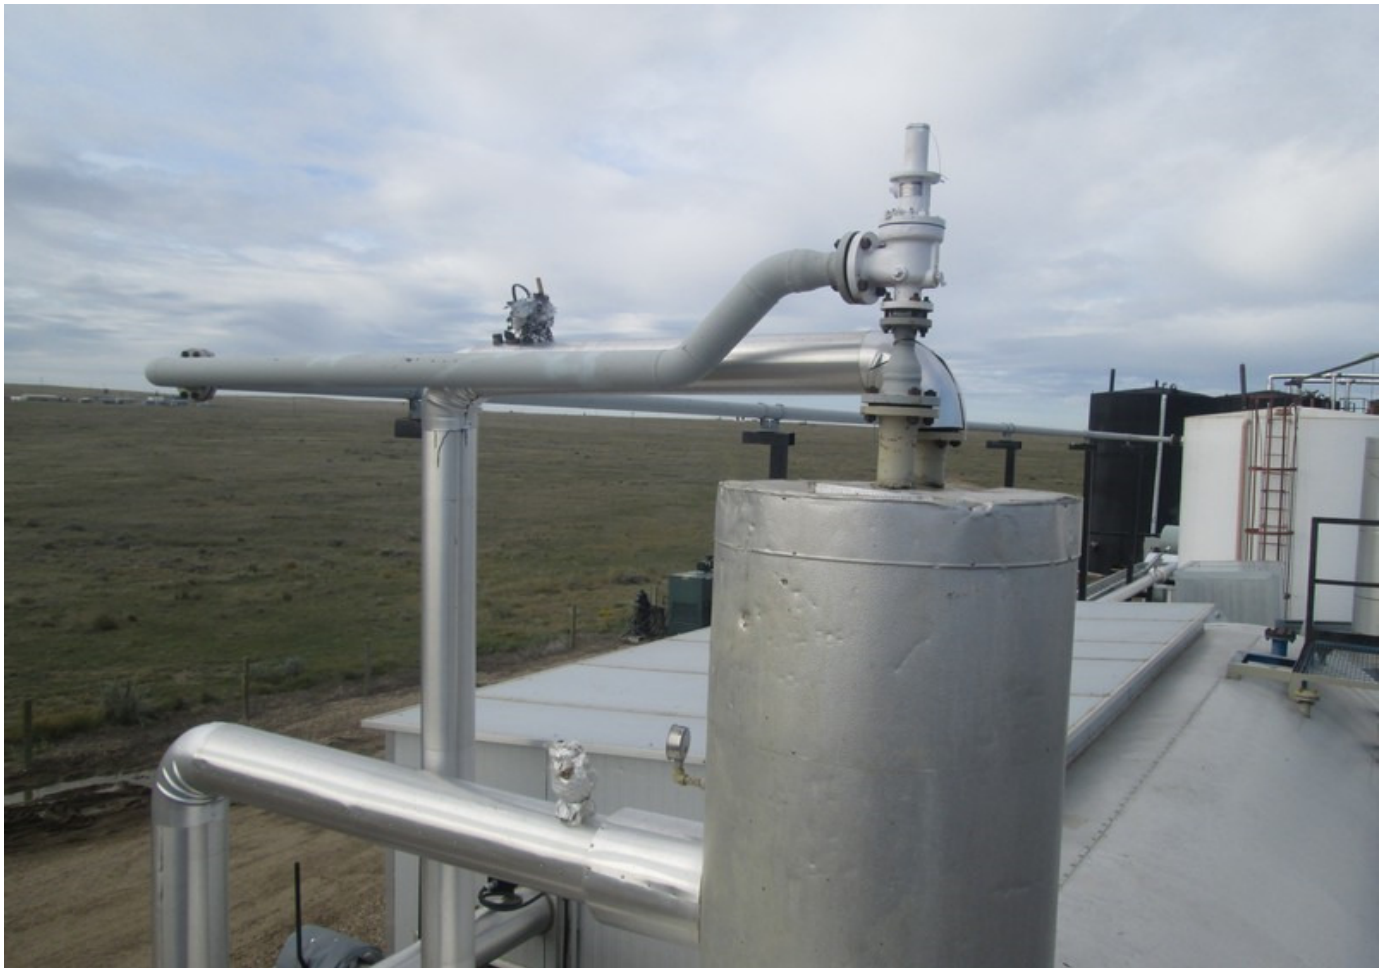
REPAIRED BY:   **REPAIR**

P/N	SET PRESS. 74	PSI
S/N	BACK PRESS.	PSI
CAP	SCFM	PSI
CAP 209	GPM	PSI
ASME SECT	COLD DIFF	PSI
WFG	TEST PRESS	PSI
CRN	SERVICE TEMP	
	DATE	2/19/2015
