**Enerplus Resources
GENERAL PRESSURE VESSEL INFORMATION**

Job # 105.00090

District: B.C. and North	Equipment number: 23465
Facility: Firebird Battery	Location (LSD): 08-11-98-08 W6M Skid: 3219
Vessel Name Equipment Number: Oil Treater	
Orientation: Horizontal	
Status: In service	Regulatory Inspection

Photo Table for E-23465 Oil Treater

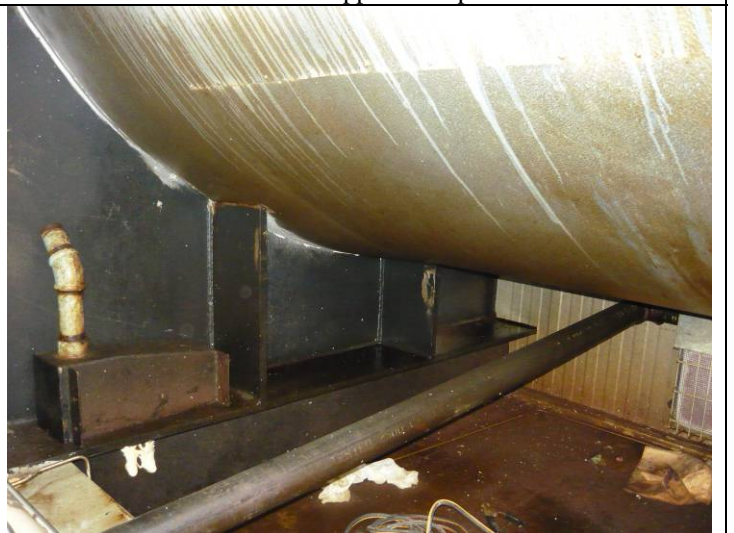
Anchor Bolts Hammer tap to ensure secure. Look for cracking in treads or signs of deformation.	X				Saddle is welded to skid floor no anchor bolts present.
Concrete foundation Check for cracks, spalling, etc.				X	
Ladder / Platform Describe general condition, ensure support is secure to vessel, describe any hazards.				X	
Nozzle Assess paint, look for leakage, and ensure stud threads are fully engaged. Record any damage, deflection, etc. Are nozzles gusseted?	X				Nozzle paint is in good condition, no stud threads present, threaded fittings fully engaged,, no damage or deflection present. No gussets present.
Gauges Ensure gauges are visible, working, no leakage, and suitable for range of MAWP/ Temp.	X				Pressure Gauge (0-15 PSI) Suitable for MAWP of Vessel Temperature Gauge (-20-120 ° C) Suitable for Temp Range
External Piping Ensure pipe is well supported. All clamps, supports, shoes, etc. in place. Look for evidence of structural overload, deflection, etc. Paint condition, external corrosion?	X				Piping is well supported and in place. Missing and loose piping clamps present see photos. No evidence of structural overload or deflection. Paint is in good condition. Produced water piping has corrosion up to 1.5mm wall remaining from 5.54mm 2" XS (73%) wall loss. See UT Report for Details

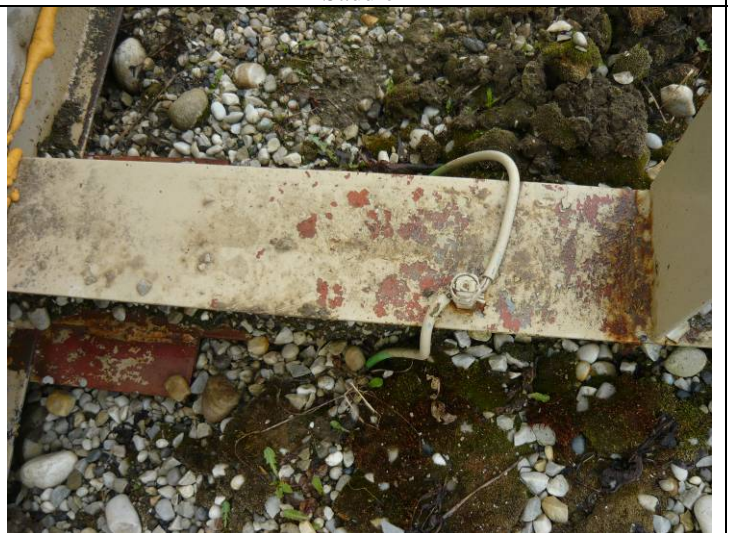
Ground Connection

External Inspection Items	G	F	P	N/A	Comments
Insulation Verify sealed around manways, nozzles, no damage present, and there is no egress of moisture.	X				Insulation Present to 70% of shell surface. No damage to cladding present.
External Condition Assess paint condition, areas peeling, record any corrosion, damage, etc (record location, size and depth of corrosion or damage)	X				Paint is in good condition. No corrosion or damage present.
Leakage Record any leakage at flanges, threaded joints, weep holes on repads, etc.	X				No Leaks Present. Thread joints are not leaking
Saddle/Skirt Assess condition of paint, fire protection, concrete. Look for corrosion, buckling, dents, etc. Look at vessel surface area near supports. Verify no signs of leakage at attachment to vessel and attachment welds are acceptable. Ground wire attached?	X				Saddle is welded to skid; paint is in good condition, no signs of corrosion, buckling or dents present. No leakage present at attachment welds to vessel. Attachment welds are acceptable. Skid is grounded.

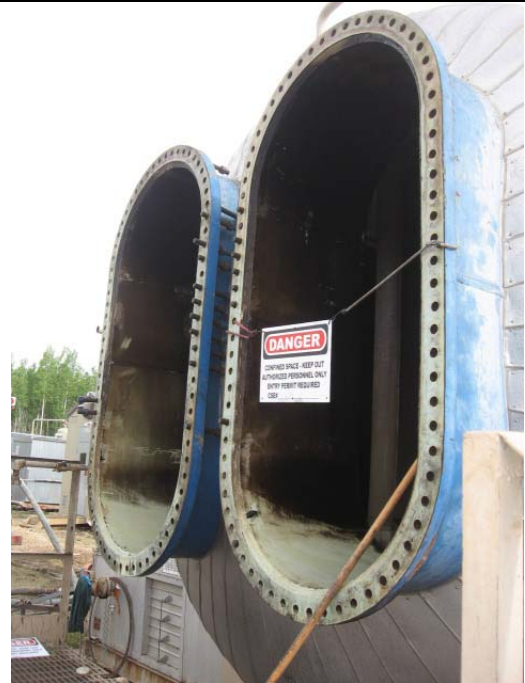
Fire tube access areas

Internal Inspection Items	G	F	P	N/A	Comments
Coating Assess coating. Describe area coated, general condition of coating.	X				Coating in good condition, no chipped coating or blisters internally. Chipped coating at fire tube man way – no corrosion.
Anodes. How many, type, condition. % consumed. Are they being replaced?			X		2 anodes in the front end and 2 in the back end. The front end anodes are completely consumed. The back end anodes are consumed to 70%. All 4 were replaced this outage.
Internal Piping Is there any? If so, carbon or stainless steel. Describe condition, dents, corrosion, erosion, etc. Ensure supports are secure and any bolts are suitable for future use.	X				Fuel gas piping in good condition, no dents. Piping is coated, no exposed metal – no corrosion. No mechanical damage.
Trays How many? Type of material. Are valves in place. Check for erosion/ corrosion; wear on tray valve legs. Cleanliness?	X				There is a single strainer tray section in the back end but all other trays and grid sections have been removed in the past. There are 2 sparging chutes in the back end – these are in place, well supported, and coated with epoxy.

Repairs Required. If yes, ensure procedure and copy of AB 40 is on file, and one sent to local ABSA, and Chief Inspector	X				<ol style="list-style-type: none"> 1. Hand patch chips in fire tube access area – completed this outage. Completed 2. Clean out all nozzles of obstructions. Completed 3. Clean out all controllers and ensure serviceability. Completed 4. Replace all anodes. Completed 5. Review operational process to ensure internals are not destroyed.
NDE Was any NDE done. (MI coordinator to review results)	X				Magnetic particle inspection carried out on all fire tube welds – no cracking detected.
<p>Recommendations or corrective actions : Vessel is Fit for Service or describe corrective actions required) (MIC to review corrective actions with Operations, discuss with Chief Inspector where necessary, and get remedial action implemented) Recommendations: See repairs required.</p> <p>Summary: Vessel in good overall condition, visual internal and external inspections carried out – internal is 100% coated with epoxy – no failed areas, no corrosion or pitting. There has been some deformation of the internal chutes and weir in the past – this seems to be caused from an increase in differential pressure in process from the sudden surge on inlet pressure – some review may be required to ensure this does not break the weir loose from its welded position. Vessel is fit for service.</p>
