Field Inspection Report

Client	CNRL		Date of Inspection	September 9, 2014					
Prov. Reg.#	A2710237		Inspection Type	VI, VE, UT, MPI					
Equipment	Group Treater and Firetube		Location	Ralston Oil Battery					
Tag/Equip. #			LSD	05-14-018-10W4M					
Vessel Status	In Service		Comp./Unit #						
Manufacturer	Natco Canada		MAWP / Temp	75 PSIG @ 200 F					
Serial #	L-8-325	CRN #	H 0995.2	MDMT@ Pressure	-5 F @ 75 PSIG				
Corrosion Allowance	0.0625"	Shell Material	SA516-70	Shell Thickness	0.975"				
Year Built	1991	Head Material	SA516-70	Head Thickness	0.598"/0.667"				
Diameter	8' OD	Length		Height		RT	RT-4	HT	
Service	Sour	Next Inspection		Next Insp. Type					
ASME Stamp	Yes	Next Inspection		Next Insp. Type					
PSV Tag #		CRN#		Set Pressure	75 PSIG				
Manufacturer	Consolidated			NB#		ASME Stamp			
Type/Model	1905JC2-X-SG10	Serial	90C3880	Inlet Size	2"				
Capacity	2271 SCFM	Service Company	Unified Valve	Outlet Size	3"				
Service Date	10/08/2013		Next Service Date

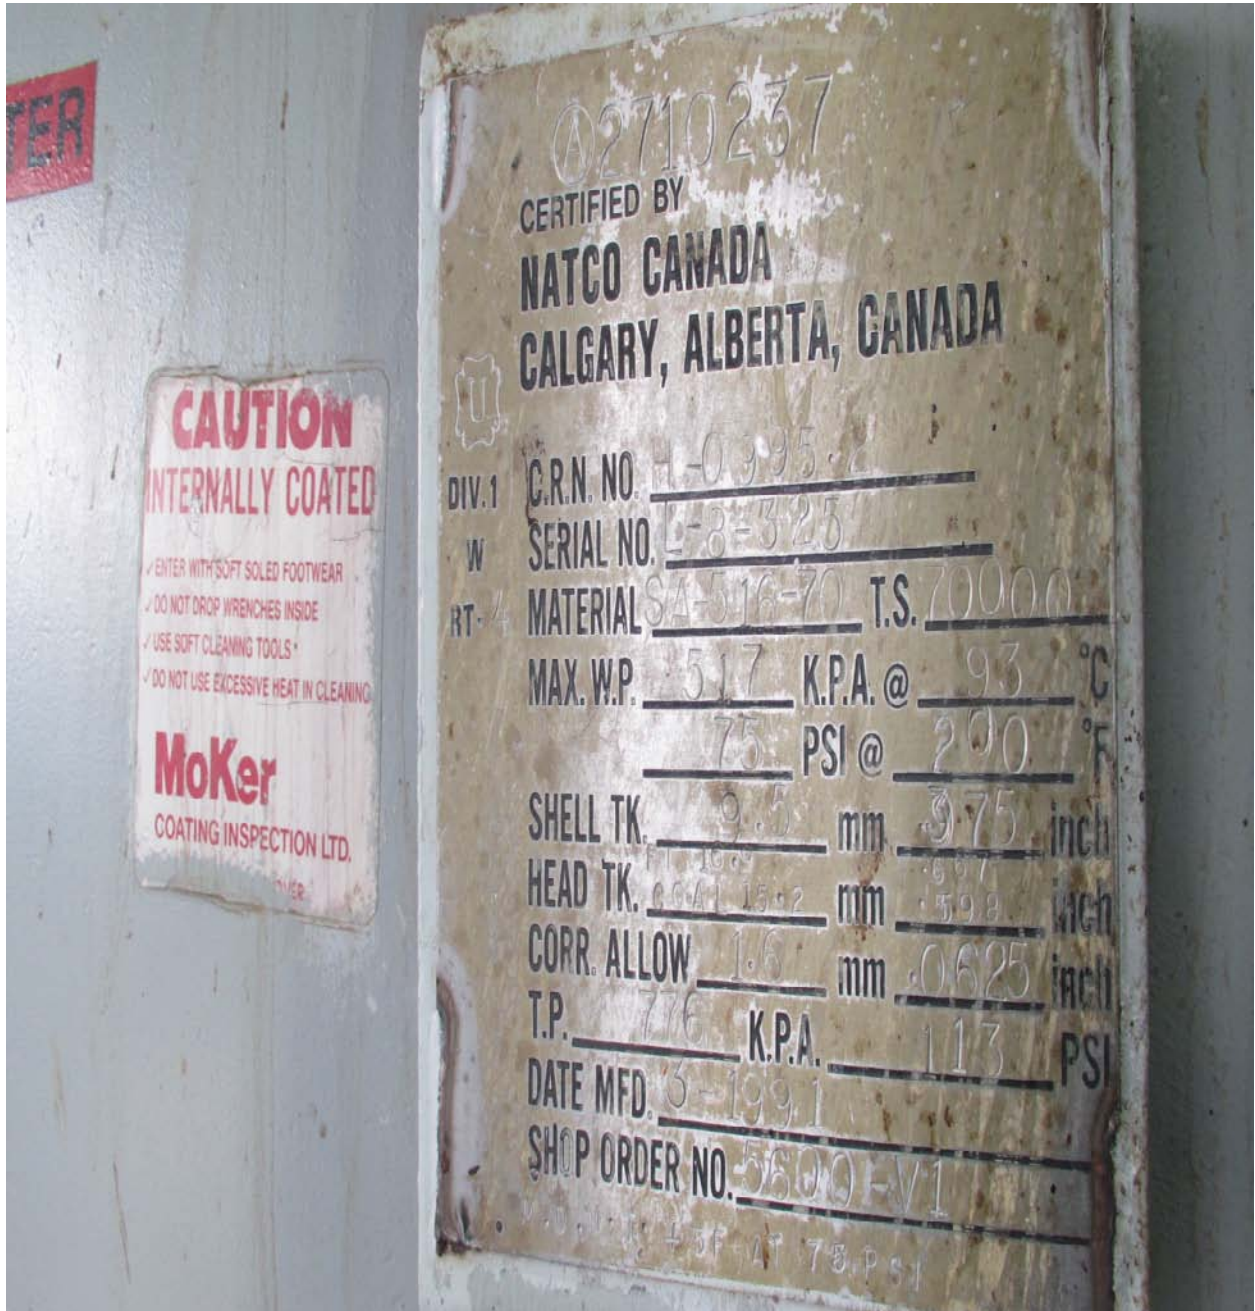
A2710237_Name plate_9Sept2014

- Name plate was attached and readable.
- External paint was in good condition with no signs of external corrosion noted.
- External insulation was intact and in good shape.
