VESSEL INSPECTION SUMMARY

Report #: 137868-WG-13
 Inspect Date: 06/09/2009
 Page: 1 of 2
 IRISNDT #: 137868

Client: CNRL	District: Medicine Hat	Field: 07-32-012-13W4
Facility: Grand Forks	Unit: Oil Battery	LSD: 07-32-012-13W4
Jurisdiction #: A2698238	Equip Tag #:	Serial #: P90-0038-A
CRN #: K3252.2	Nat'l Bd #:	Year Built: 1991
Manufacturer: Process Industries	Equipment Description: Free Water Knock Out (FWKO)	
Status: In Service	Date Removed From Service:	Service: Sour
MAWP Shell 75 Psi @ 200 °F	Height/Length: 432 in.	Code Stamp: <input checked="" type="checkbox"/> Y <input type="checkbox"/> N
MAWP Tube Psi @ °F	Size/Diameter: 120 in. O.D.	Insulated: <input checked="" type="checkbox"/> Y <input type="checkbox"/> N
Support Type: Saddle RT: 2	Volume: ft ³ / m ³	PWHT: <input type="checkbox"/> Y <input checked="" type="checkbox"/> N
C.A. 0.0625" Coated <input checked="" type="checkbox"/> Y <input type="checkbox"/> N	Clad: <input type="checkbox"/> Y <input checked="" type="checkbox"/> N	Manway: <input checked="" type="checkbox"/> Y <input type="checkbox"/> N

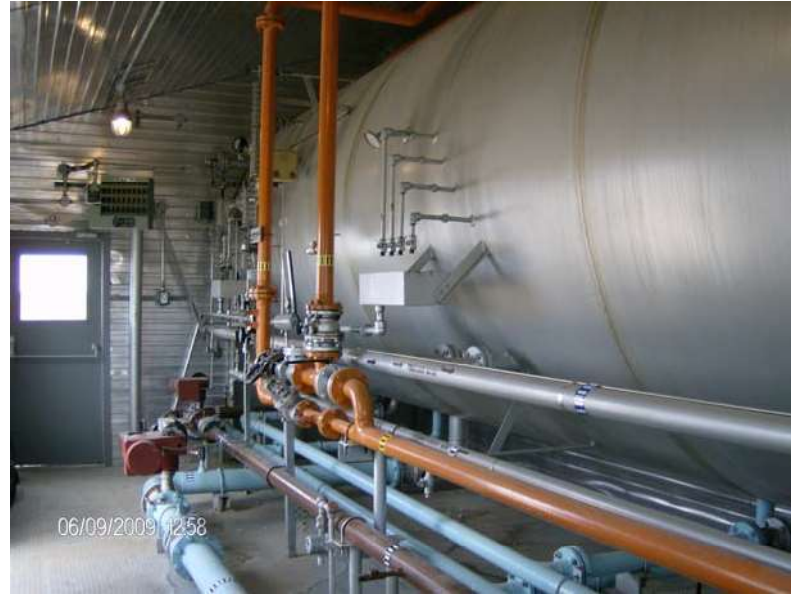
Grand Forks-FWKO_Inside Bldg.

The vessel was removed from service for cleaning and inspection. Associated flanges/bolting/gaskets/threads were intact and showed no evidence of deterioration, visible cracking or process leaks. All inside uninsulated piping found to be secure and in acceptable condition with no corrosion.

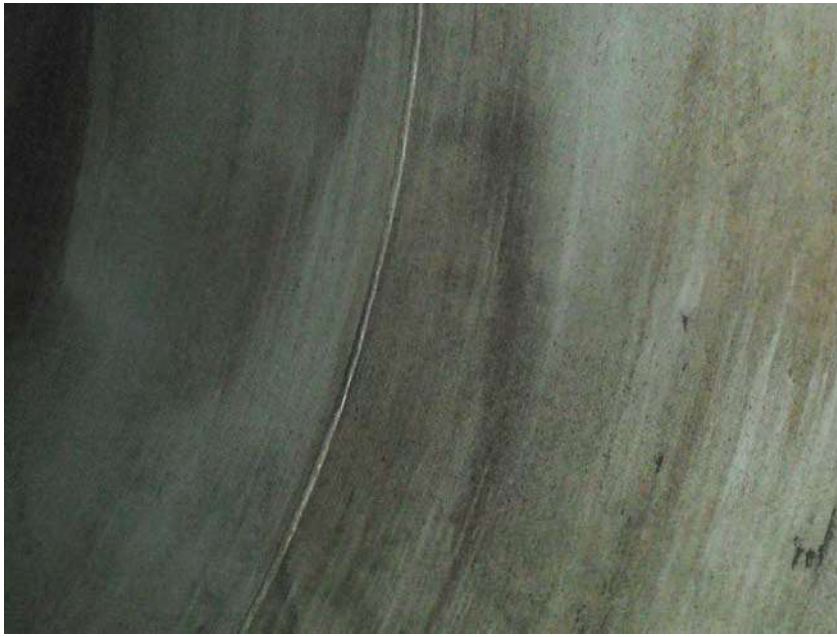
Grand Forks-FWKO Internal View of Shell

Ultrasonic Corrosion Survey conducted by Kris Katryniuk. All UT readings were found to be acceptable at time of inspection. All UT readings referenced to Dwg. 137868-KK-12 and recorded in client's Maxitrack account.
