APPLUS-RTD EDMONTON, ALBERTA, CANADA T6P 1N5 Tel: (780) 440-6600 Fax: (780) 440-2538				GENERAL NDE REPORT A-3141304_06_21 2013 MT-Report-b					
					Date _June 20 , 2013					
					RTD Job #: 10-113249

A-3141304_21-06-2013_MT-Report-b

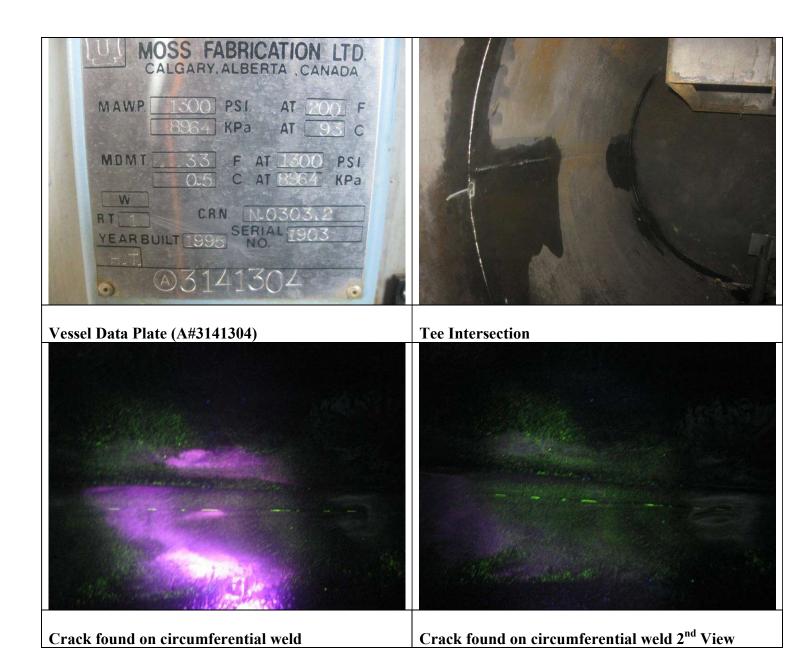
Туре		1 2		Level (dB)	Level (dB)		1	Travel	Value (dB)	
Scope:	Corry	out Magnatic	Dorticle Inc	INSPECTION pection on all in	N DETAILS	oregotions no	zzlos Inlot di	ffusor wolds	to shall	
scope.										
demister support cage to shell and manway weld to shell in the (High Pressure Inlet Separator- A-3141304).										
D 1:	(4)	\			e 1	11 10	1 1/44 / 1/44 *			
Results: (1) At East shell tee intersection the circumferential weld had (9) cracks ¼" to ½" in length running circumferentially.

(2) All (8) lower Cracks were removed with light remedial grinding with 80Grit flapper, with										
substantial weld cap remaining.										
(3) The top crack at $\frac{1}{2}$ " length above tee intersection was removed with light remedial grinding with 80grit										
flapper flush with shell.

(4) All were re-inspected and found acceptable.										
Technician:	Jerry Hryn	kiw	CCCD /ACM	T/CMT Lovel. II	Start Time:	Stop	Tima:	ST	OT	
Signature:	Jerry Hryn	K1W		T/SNT Level: II MT #5709	Unit:	Stop	Km:	Travel Time:	- 01	
Assistant:				T/SNT Level:	I —	Subsistence required OT Meal				
Client Sign	ature:					Consumables:
