**Canadian Natural Resources Limited  
GENERAL PRESSURE VESSEL INFORMATION**

**Job # 10.111479**

Facility: **South Spirit River Unit #1 Battery** Location (LSD): **08-09-77-07 W6M**

Vessel Name Equipment Number: **Flare Knock-Out Drum**

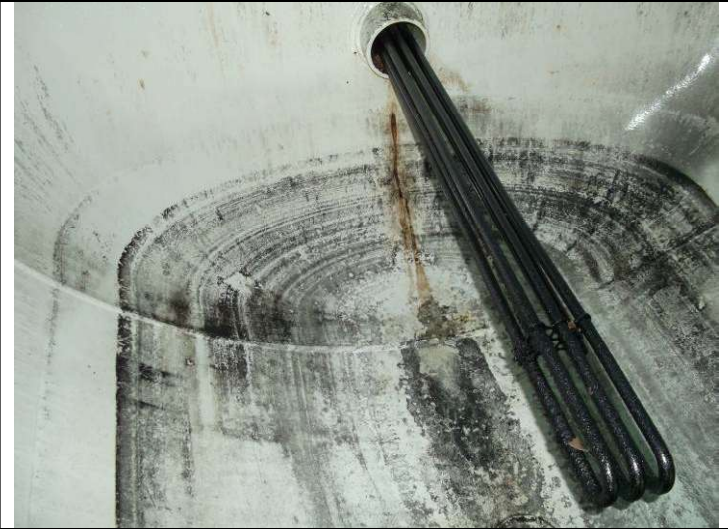
**West heater bundle and lower shell**

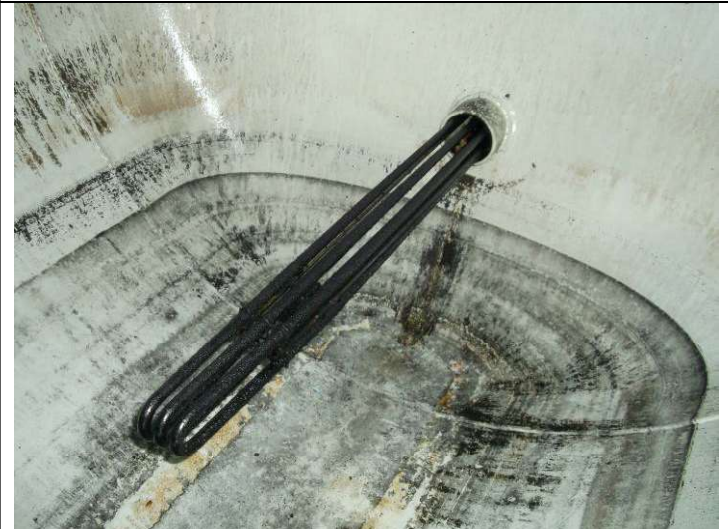
<b>East Head</b> Note all corrosion, erosion or mechanical damage. (If vessel is horizontal identify direction of this head)	X				<b>100% coated no areas of failed coating. No damage. No corrosion. Electric heating coil installed. Good condition- no damage.</b>
<b>Shell Sections</b> Record number of shell sections. Record location, size and depth of all erosion, corrosion or mechanical damage. Describe General condition.	X				<b>Two shell sections in good condition. No damage. No corrosion.</b>
<b>Demister pad</b> Is it in place? Is it clean? If any corrosion is apparent in vessel, lift pad and check top head for corrosion.				X	<b>None</b>
<b>Welds</b> Inspect all welds, including attachment welds. Record all service-related damages and if there is any discuss with Chief Inspector before closing.	X				<b>Welds are coated and are in good condition. No pitting. No corrosion.</b>
<b>Repairs Required.</b> If yes, ensure procedure and copy of AB 40 is on file, and one sent to local ABSA, and Chief Inspector				X	<b>None.</b>

**East heater bundle and lower shell**
