**Canadian Natural Resources Limited
GENERAL PRESSURE VESSEL INFORMATION**

Job # 10.112250

District: BC and North	Skid No.
Facility: Chinchaga Battery	Location (LSD): 13-20-96-09 W6M

Tank Name / Equipment Number: **1000 bbl Produced Water Tank**

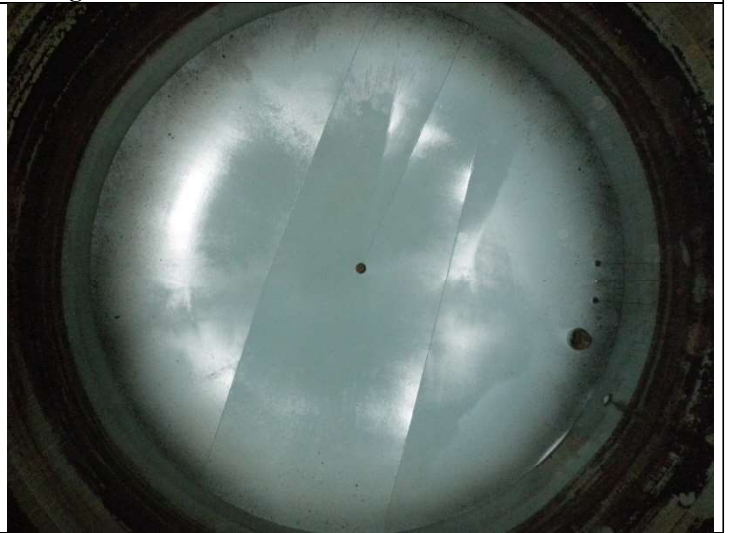
Deck Note all corrosion, erosion or mechanical damage. (If vessel is horizontal identify direction of this head) Exchanger may have 2 pancake covers instead.	X				Coating intact. No signs of damage or distortion.
Shell Sections Record number of shell sections. Record location, size and depth of all erosion, corrosion or mechanical damage. Describe general condition.			X		4 shell courses. Pitting/corrosion exists at floor to shell weld. Upper courses have tightly adhered to product. No signs of coating damage behind product scale.
Thermal Wells If present, describe condition and location.				X	No thermal wells
Heat Medium Coil Note all corrosion, erosion or mechanical damage.				X	None.
Fire Tube Note all corrosion, erosion or mechanical damage. Take thickness readings on selected areas of tube and carry out Magnetic Particle Inspection on tube welds.			X		Corrosion and pitting exists. Pitting depths measured to 0.200 inches. Product covered.
