| GENERAL INSPECTION FORM | | | | | | |
| Facility: South Wapiti Gas Plant | | | Location (LSD) Surface: 16-36-67-09 W6M | | | |
| Vessel Name & Equipment Number: Inlet Separator | | | PSV Only-Installed on piping: <input checked="" type="checkbox"/> | | | |

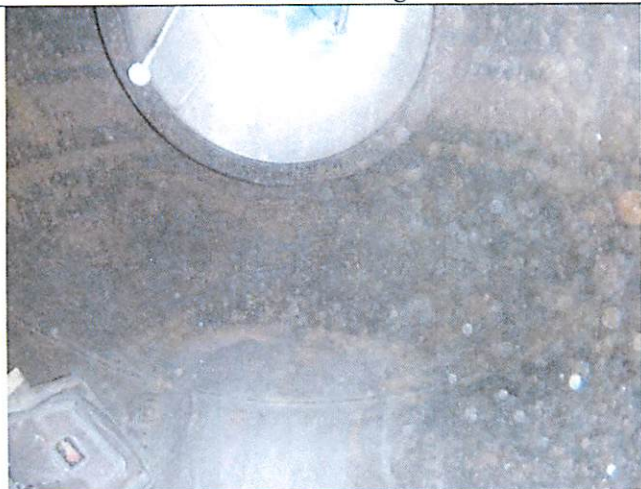
Manway

| Internal Inspection Items | G | F | P | N/A | Comments |
|---|---|---|---|---|---|
| <b>North Head (Manway)</b> Note all corrosion, erosion or mechanical damage. (If vessel is horizontal identify direction of this head) | X | | | | No pitting, corrosion or mechanical damage. |

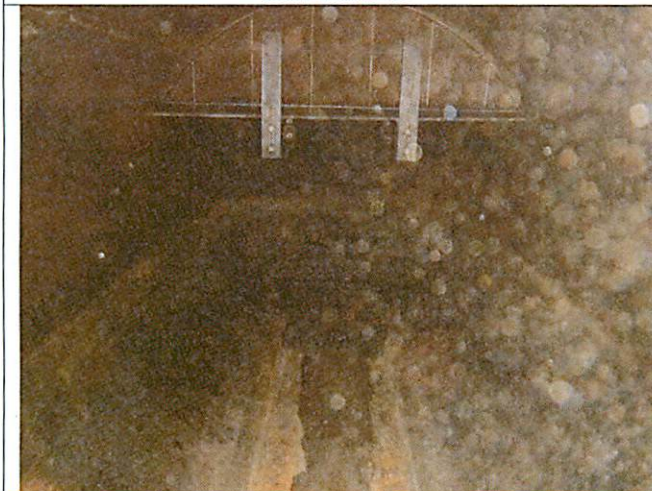
Overview - Internal

| Internal Inspection Items | G | F | P | N/A | Comments |
|---|---|---|---|---|---|
| <b>Shell Sections</b> Record number of shell sections. Record location, size and depth of all erosion, corrosion or mechanical damage. Describe general condition. If any corrosion greater than corrosion allowance is observed in either shell or head, discuss with Chief Inspector before closing vessel. | X | | | | Two shell sections.<br>All in good condition – no pitting, corrosion or damage noted. |
