GENERA	L TANK	INFORMATIO	ON				
District: Slave L	ake			Skid No.:	BAR1				
Facility: Barney Pads			Location (LSD): 09-13-080-21W4						
Name & Equip No: AST - C81055			Orientation: Vertical						
Company: CNRL				Cost Code:					
Status: Shut-Ir	1			Operating Province: Alberta					
Unit:	W.O/P.O No	u:		Unique ID: ONCOR ID: 64856					
		TANK	NAME	PLATE DATA					
			Registration Nu	ımber (0	Other):				
Serial Number: F-9	7-019-12			Tank Height:		288.00	(In)	7315.20	(mm)
Manufacturer: GLI	M TANKS & EQUIPMENT LTD			Tank Diameter	:	183.00	(In)	4648.20	(mm)
Year Built: 1997				Tank Volume: 750.00					
Туре:				Floor Material:					
Secondary Containme	nt: Yes			Floor Thickness: 0.25 (In)		6.35	(mm)		
External Cathodic Protection: Yes			Roof Material:						
Corrosion Allowance: (In) (mm)			Roof Thickness	i:	0.19	(In)	4.78	(mm)	
Internally Coated: No			Containment L	ength:		(In)		(mm)	
Skid Mounted: No			Containment Width: (In)			(mm)

Internal Inspection

STORAGE TANK SURVEY DRAWING

MAGNETIC FLUX LEAKAGE (MFL) REPORT

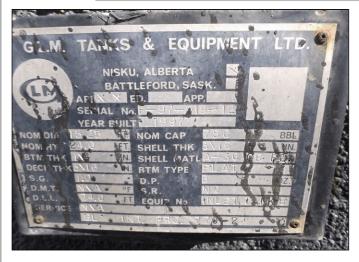
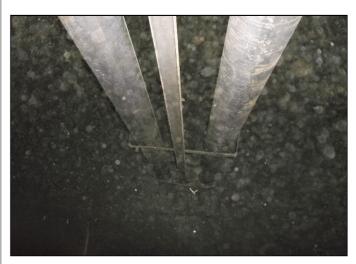
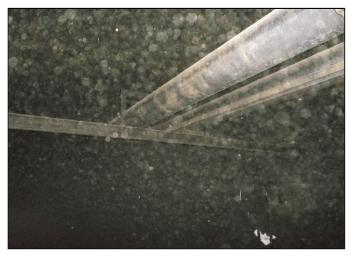
Inspection Date:	May 23, 2013	Inspection Interval:	İ	Next Insp. Date:		
<u>Item</u>	Condition	Inspection Comments				
General Condition	Accept	GOOD CONDITION.				
Insulation	Accept	GOOD CONDITION.				
Containmen	Accept	GRAVEL BERM WITH POLY LINER.				
External Corrosion	N/A	INSULATED.				
External Welds	N/A	INSULATED.				
Bolted Tanks	N/A					
Bolted Tanks	N/A					
Manway	Accept	MANWAY & MANWAY DOORS IN GOOD COND	ITION.			
Supports/Structural	Accept	GOOD CONDITION.				
Internal Welds	Accept	GOOD CONDITION.				
Coating	N/A					
Floor	Accept	PERFORMED SPOT UT & MFL FLOOR SCAN.				
		NO DAMAGE OBSERVED.				
Shell	Accept	GOOD CONDITION.				
Dark	At	MINOR DENT/BULGE ON SOUTHEAST SHELL R	OUGHLY 4" FROM FL	OOR.		
Roof	Accept	GOOD CONDITION.				
Internal components	Accept	GOOD CONDITION.				
Anodes	N/A					
NDE	Accept	PERFORMED SPOT UT ON FLOOR & 1ST SHELL PERFORMED MFL FLOOR SCAN.	L SECTION.			
Other	Concern	TWO TRANSPORTATION SKIDS OBSERVED TO	BE BREAKING AWAY	FROM TANK.

Recommendations:	TANK IS FIT FO	R SERVICE.	Inspected By:	Jamey Tanasichuk	ABSA PESL #:	000411
	RECOMMEND TO) RE-ATTACH TRANSPORTATION				
	SKIDS BEFORE	MOVING TANK.				
	·	·	·	· ·	· ·	•
