## Ultrasonic Inspection Report

Report #:	125209	-UT-BV-09	IRISN	NDT Job #:	1	125209	Date:	MARCH 26, 2008	Page	<b>1</b> of	1		
Client:	CNRL PO/Job #: 16980:					592.5430.1	15-G829	Contact:	BRAD	BODNAR	_		
Job location:	CHIN COULEE, MEDICINE HAT WEST, ALBERTA							Tel:	(403)	634-2453			
LSD. 03-19-008-16 W4M Fax: (403) 223-8318													
Procedure(s):	re(s): UT THICKNESS												
Code(s):	Code(s): ASME SECT VIII

Item Inspected: Test Separator A3028074 Material: Carbon Steel													
Method:	•						Surface Temp (C): $\boxtimes < 5^{\circ}$ $\square > 5^{\circ} / < 60^{\circ}$ $\square > 60^{\circ}$						
Type:	Type: ☐ P/E ☐ T/T ☐ Dual ☐ Automated ☐ TOFD							Scanning Surface:					
Application: ☐ Laminar ☐ Shear Wave ☐ Volumetric ☐ Thickness Surface Condition: ☐ Good													
Instrumentation: Manufacturer: Krautkramer Type:								Instrumen	t Ser. #:	31530			
Calibration: Date: Jan 10, 2008 Reference Flaw Size:								IRISNDT #: <b>31530</b>					
Calibration Block(s): Type: Step Wedge - I IRISNDT #: 1							Type:	IRISNDT #:					
Type: IRISNDT #:							Type:			IRISNDT #:			
Couplant: Br	and: Ec	hogel	Type:	971		Cable:	Type:	Coaxial		Length:	36"		
Probe							ETTINGS -

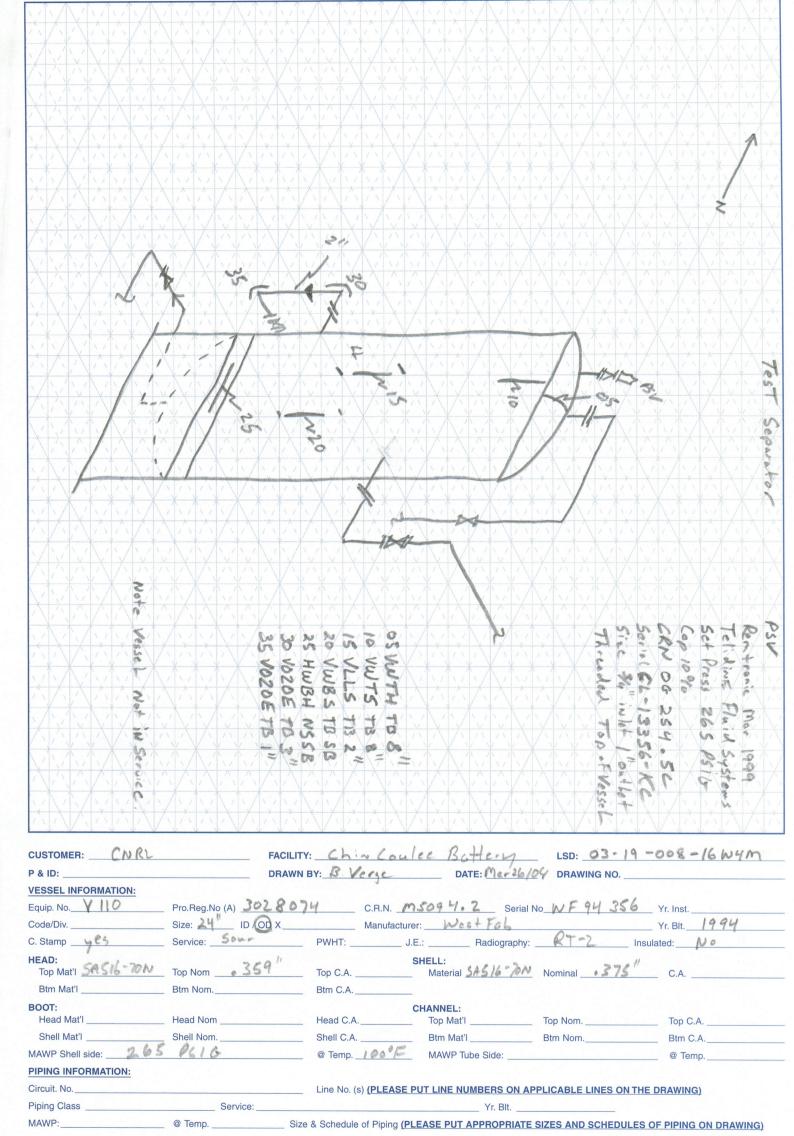
Recommendations: Carry out Visual External inspection at the next opportunity and also continue to carry out UT													
Corrosion survey at the required frequency. See attached drawing, pictures and UTM file for locations and thicknesses recorded.													
See attached drawing, pictures and O 1191 the for locations and unicknesses recorded.													
Final Comment: Test Separator A3028074 is fit for service.													
Assistant:						Technician: BLAIR VERGE							
☐ CGSB ☐ SNT UT Level: ☐ I ☐ III ☐ III No.#:						☐ CGSB ☐ SNT UT Level: ☐ I ☐ II ☐ III No.#: 5586							
Unit: 393 Km: Travel Time:							Signature:						
Start:	Start: Stop: Work hrs:												
OT Meal	otal hrs:	Client Na	Client Name:										
Consumables:		Signat	ure:										
						I
