Client:  
**CNRL**

## PRESSURE EQUIPMENT DATA REPORT

<b>District:</b>	Medicine Hat		
<b>Facility:</b>	Grand Forks Central		
<b>Location /LSD:</b>	07-32-012-13W4	<b>Operating Province:</b>	Alberta
<b>Equipment Name:</b>	GROUP TREATER		
<b>Equipment Status:</b>	Operating	<b>Orientation:</b>	Horizontal
<b>Skid No.:</b>	GROUP TREATER	<b>Unit:</b>

**VISUAL INSPECTION REPORT**

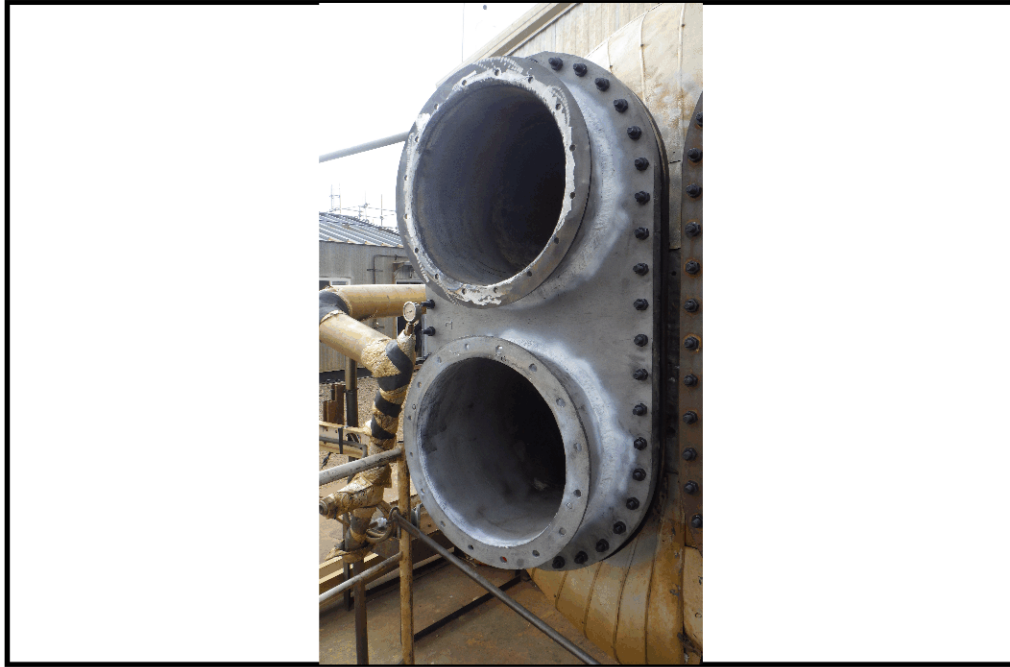
OVERALL REPAIRED
